# Justering af Camber vinkel på IRS modeller

## TR250 & TR6 Steering & Suspension Adjusting Rear Suspension Camber

*By Nelson Riedel*

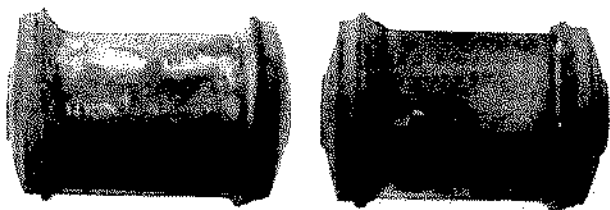
**Bushes:** The standard bushes are made of rubber with metal sleeves in the middle. After years of use, the sleeves tend to migrate to one side of the bush. Since the forces on the inside and on the outside bushes are different,

the amount of sleeve movement can be different enough to cause several degrees of negative camber. The next photo shows a pair of bushes removed from the trailing arm on my '70TR6. Notice that the sleeve on the left has migrated to the top more than the one on the right.

If the bushes are more than ten years old I'd suggested replacement before doing anything to adjust the camber. The standard bushing as well as uprated rubber and poly bushes are available. I installed new standard bushes on my '76 about 18 months ago at the same time I replaced the frame rear cross members, that part of the frame to which the trailing arm brackets attach.

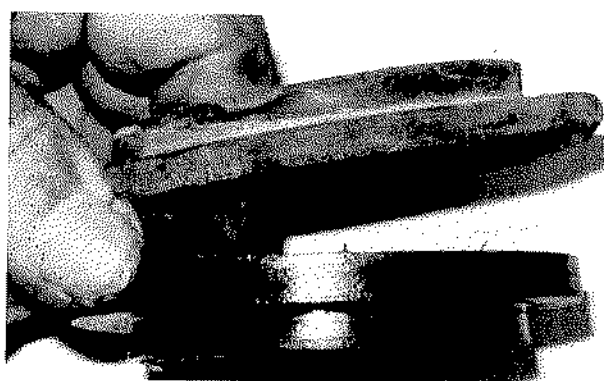
**New Packing:** When measuring the fitted spring length I noticed the rubber packing pieces at each end of the springs were in bad shape so I decided to replace them first. I purchased the uprated poly packing pieces from TRF. The rubber packing pieces are about ~0.25" thick and the new poly packing pieces are ~ 0.29" thick (photo below)

I decided to install the new packing pieces and measure everything again.

height increased and the camber improved because of the thicker packing. The height became equal. I noticed that part of one of the old packing on the left side was not under the spring, which might explain how the height changed more on the left side.

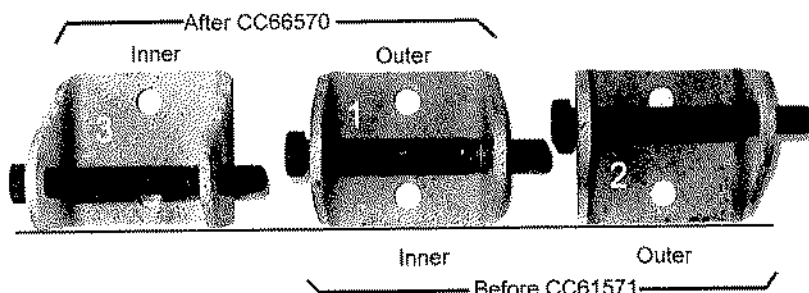
**The Brackets:** Triumph made three different brackets for the trailing arm as shown in the next photo. The number of notches in the top edges identifies the brackets and is marked on each bracket in the photo. Up to CC61570 a 1-notch bracket was used on the inside and a 2-notch bracket on the outside. Beginning with CC61571 a 3-notch bracket was used on the inside and a 1-notch bracket on the outside.

Brian suggested that it's best to change only one bracket per trailing arm at a time which makes sense. I started with the standard later 1U outer 3U inner configuration. The inner bracket bolt was installed with the head toward

the inside and I didn't know if I could get the inside bracket off easily so I decided to try to correct the problem by changing only the outside bracket. (The configuration shown in the manuals has the bolt head toward the inside. In the future I'm going to assemble them with the inner bolt head to the outside and the outer bolt head to the inside to facilitate changing the bracket configuration.)

The 1U-3U configuration has a relative camber of -2.8 degrees. Moving down the table then next entry with the 3U inner bracket is the 2D-3U configuration that has -2.3 degrees relative camber. That is an increase of 0.5 degrees—not enough. I needed between 1.3 and 1.6 degrees to get to zero camber (the spacer had been removed). The next entry down with the 3U inner bracket is the 3U-3U configuration that has -1.7 degrees relative camber. This is an increase of 1.1 degree. I would have liked a little more increase, but the 3U-3U configuration is the combination with the greatest positive camber with the 3U inner bracket. So I tried that. The results were:

This was a slightly greater camber increase than expected and very close to the +1 degrees to -1/4 degrees specification. The road height increased slightly rather than decreasing as predicted from the data in the table. The ride height increase is due to a small second order effect explained in the Geometry note. These results above are barely acceptable. I'd be much happier with the left at about + 0.6 degree and right at +0.3 degree since the left side load is nearly always more than the right side load. I decided to run it for a few weeks and then measure it again.
