# Justering af Camber vinkel på IRS modeller

## TR250 & TR6 Steering & Suspension Adjusting Rear Suspension Camber

*By Nelson Riedel*

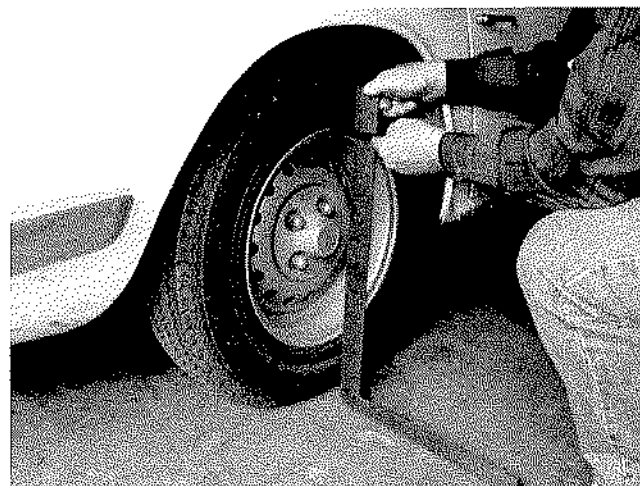
**Measuring Camber:** The first thing I did is determine if the camber is misaligned and if so, how much and in what direction. (Remember, if it isn't broke, don't fix it — or, don't treat a well patient cause you might make him sick.) All that is needed to get a rough measure of the

camber is a flat surface such as a garage floor, a large square and a ruler, preferably calibrated in tenths. The next photo shows these tools in action. (Notice the clean hands, almost like a surgeon.)
